Renovation of Mälär 30 bottom – part 1 of 2.

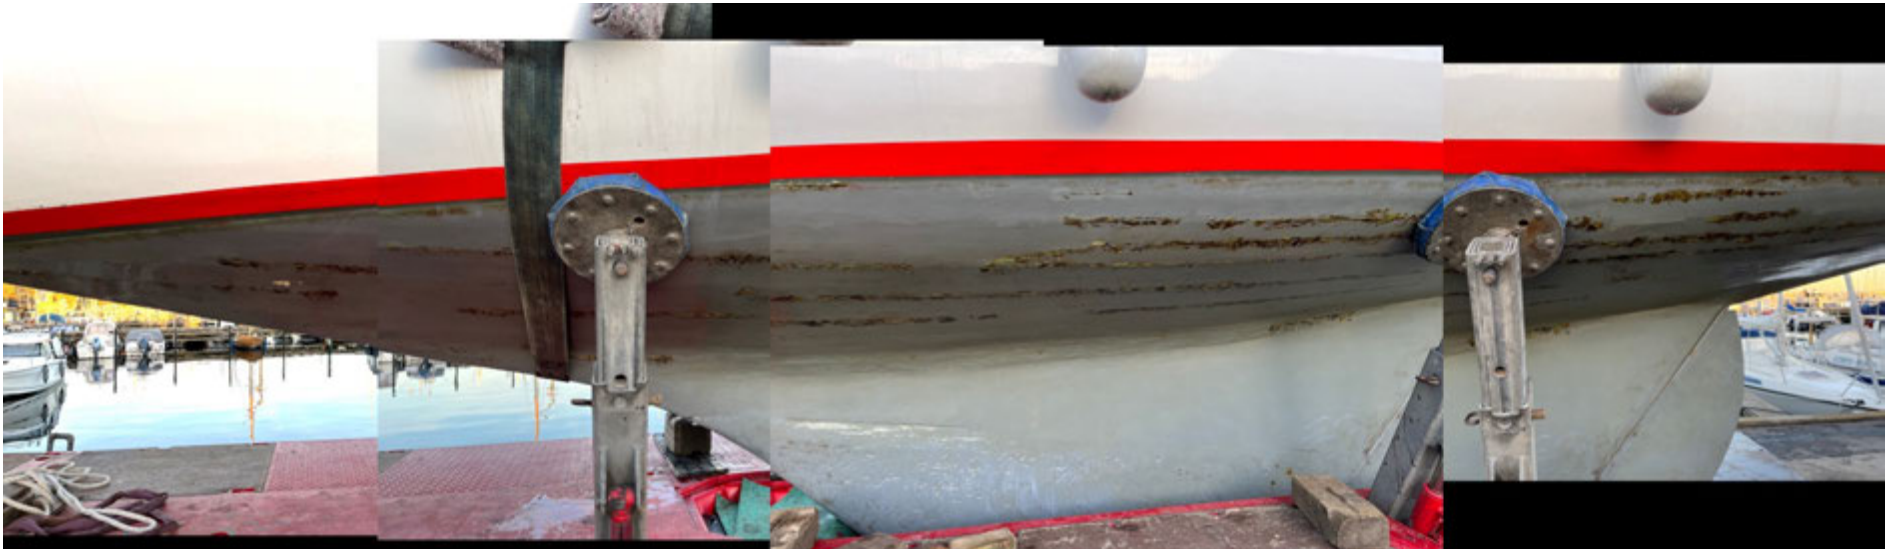
Condition of bottom October 2022

Stitched picture of Port side before renovation. The seaweed indicates the cracked seams.

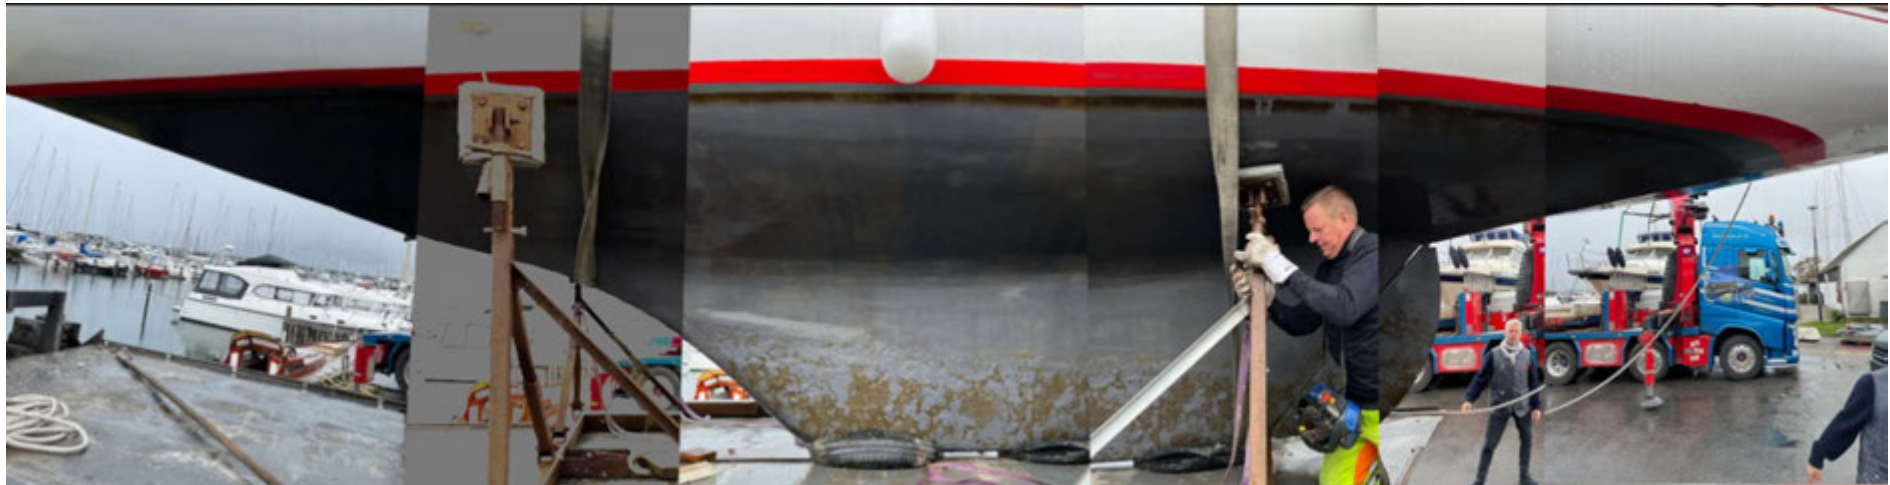
Condition of bottom October 2023

Stitched picture of Port side after renovation. All agea on ballast keel sit in the pockets we left to fill in the coming winter 23-24.

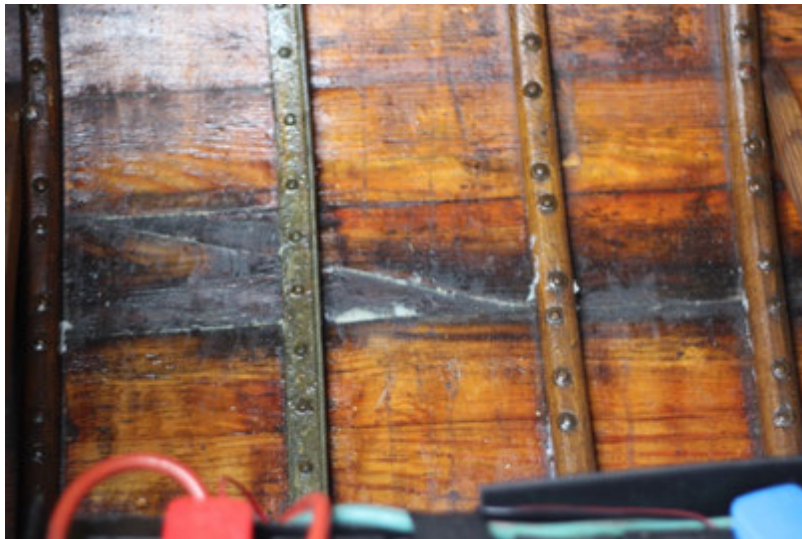
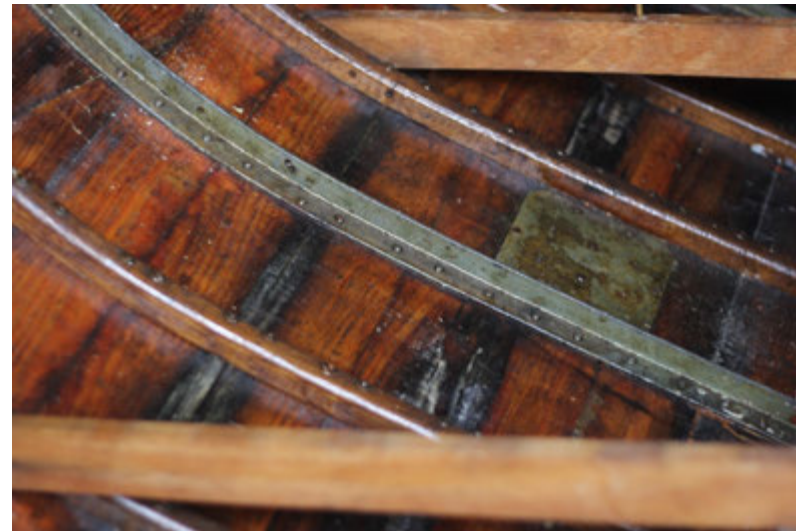
Inside condition of bottom October 2022

Here you see how black the planks get from water seeping into the wood through the leaking joints. People who say that "wooden boats always have to swell tight" do not realize how much damage water does to untreated wood, etc. In the seams that are not treated with either paint or varnish. The white stuff you see, is traces of fat that I used to seal the leaks before renovation – a Sisyphos job.
