Renovation of Mälär 30 bottom – part 1 of 2.

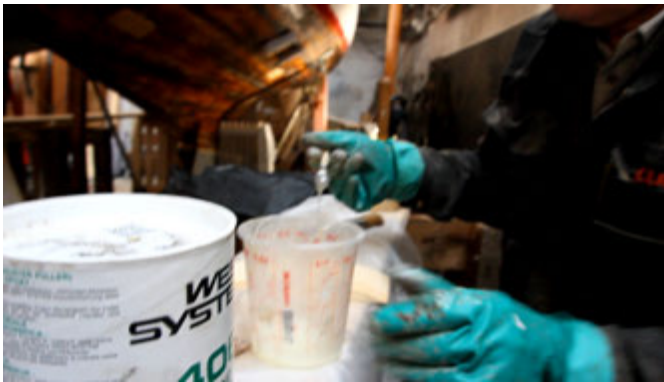
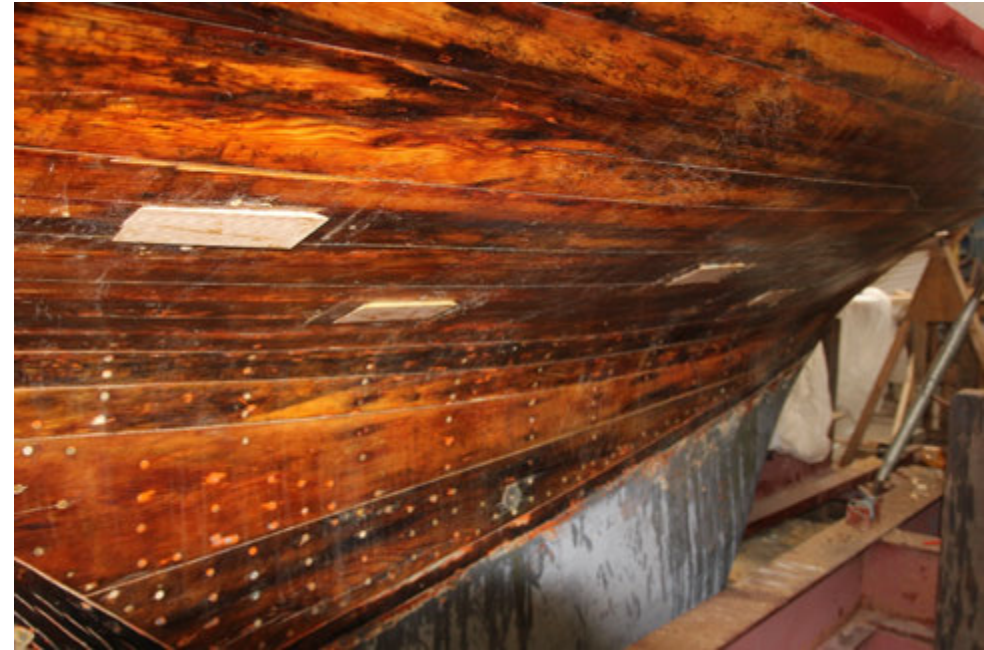
Glue new block, adjust height after 24h.

Just before this video starts, I have primed the mating surfaces on the hull with WEST epoxy.
